TEST REPORT

Sample name: SURVEILLANCE PTZ CAMERA

Sample model: APTZ20Z30-M-POE, APTZ20Z20

EN62262-2002

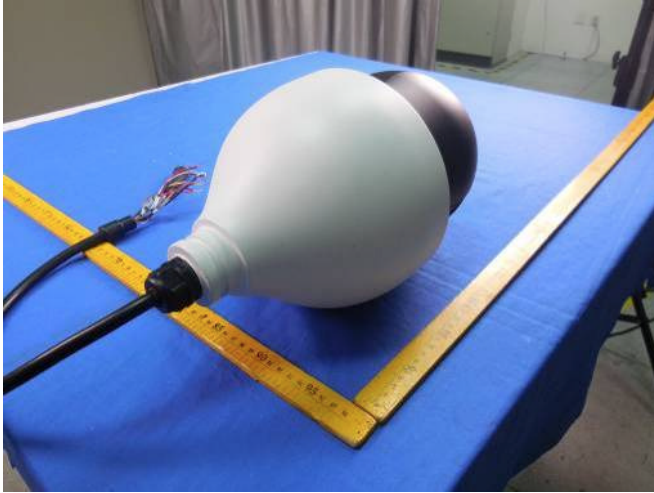
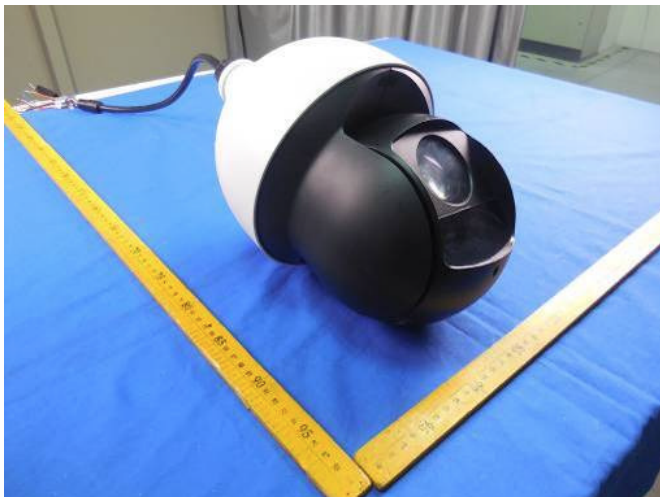
Sample name	IK level	Impact force	Test result	Test conclusion
Vandal-proof Dome Camera	IK01-05	< 1 J	Test after, Sample shell no damage.	OK
	IK06	1J	Test after, Sample shell no damage.	OK
	IK07	2J	Test after, Sample shell no damage.	OK
	IK08	5J	Test after, Sample shell no damage.	OK
	IK09	10J	Test after, Sample shell no damage.	OK
	IK10	20J	Test after, Sample shell no damage.	OK

After test sample view
